# Technical Service Bulletin

**SUBJECT:**  
Water Leaking Through  
Rear Window

**NO:** 23-27-97  
**GROUP:** Body  
**DATE:** May 9, 1997

1994 - 1997 (BR) Ram Trucks

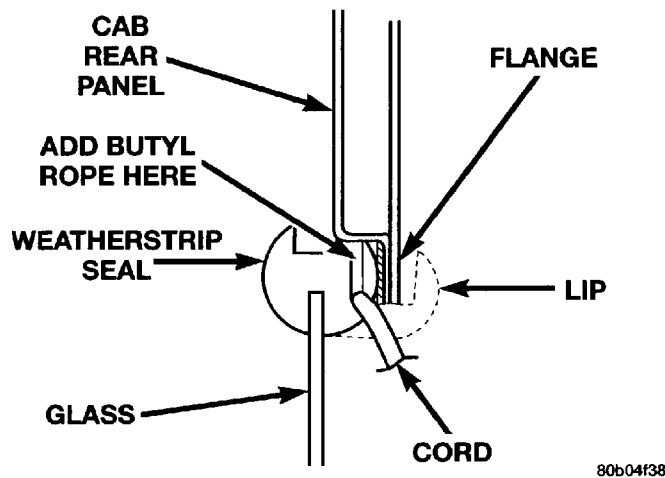
**FIGURE 1 - Rear Window Module - Fixed Glass**

#### WATER LEAKING BETWEEN THE CAB REAR PANEL AND THE RUBBER WEATHERSTRIP SEAL

To repair a water leak between the cab rear panel sheet metal and the rubber weatherstrip seal, apply the 6mm (1/4 in.) butyl rope seal to the leaking area between the rubber weatherstrip seal and the cab rear panel (Figure 1).

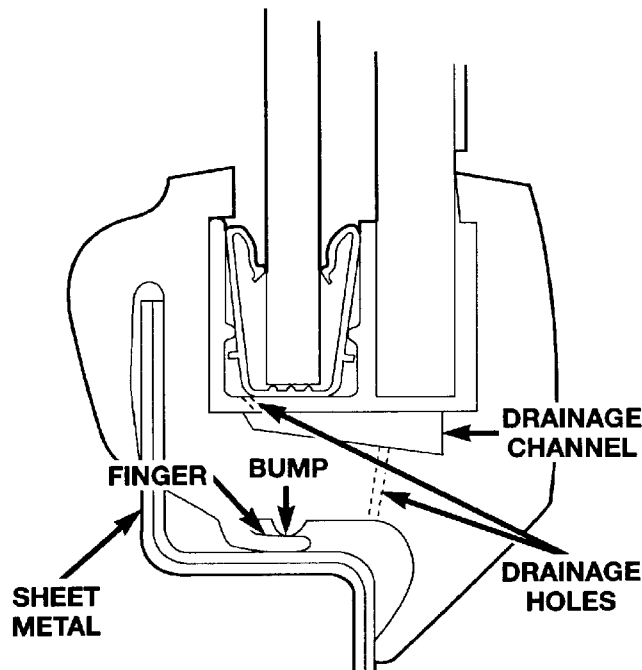
**FIGURE 2 - Rear Window Module - Sliding Window - Weatherstrip Seal At Level "D"**

### WATER LEAKING BETWEEN THE SHEET METAL AND THE RUBBER WEATHERSTRIP SEAL

Water management for the horizontal seams include drainage holes at the bottom of the rear window module sliding track and window seal (Figure 2). Check to verify that the drainage holes are clear and are not restricting water flow through them.

To repair a water leak between the sheet metal and the rear window module, apply the 6mm (1/4 in.) butyl rope seal to the leaking area between the rubber weatherstrip seal and the sheet metal (Figure 2).

**CAUTION: MAKE SURE THE BUTYL ROPE IS INSTALLED SO THAT IT SEALS TIGHTLY UP AGAINST THE WINDOW MODULE'S SEALING FINGER. FAILURE TO INSTALL THE BUTYL ROPE PROPERLY COULD RESULT IN PLUGGING THE DRAINAGE HOLES (FIGURE 2) IN THE RUBBER WEATHERSTRIP SEAL.**

**NOTE: BEFORE REPLACING THE REAR WINDOW MODULE, MAKE SURE THE REPLACEMENT MODULE IS AT LEVEL "D." VISUALLY INSPECT THE LOWER PORTION OF THE RUBBER WEATHERSTRIP SEAL FOR A SMALL BUMP IN THE SEAL NEXT TO THE SEALING FINGER (FIGURE 2) TO IDENTIFY THAT THE REPLACEMENT MODULE IS AT LEVEL "D."**

**NOTE: APPLY SEALER BETWEEN THE MOLDED RUBBER AND THE FIXED GLASS ONLY. DO NOT APPLY SEALER BETWEEN THE RUBBER AND METAL FRAME AT THE BOTTOM OF THE MODULE, AS EXCESS SEALER COULD PLUG THE DRAINAGE HOLES (FIGURE 2).**
