# Technical Service Bulletin

**SUBJECT:**  
Drive Line Vibration  
At Speeds Over 60 MPH

**NO:** 03-01-98  
**GROUP:** Differential/DriveLine  
**DATE:** Mar. 27, 1998

1997 - 1998 (XJ) Cherokee

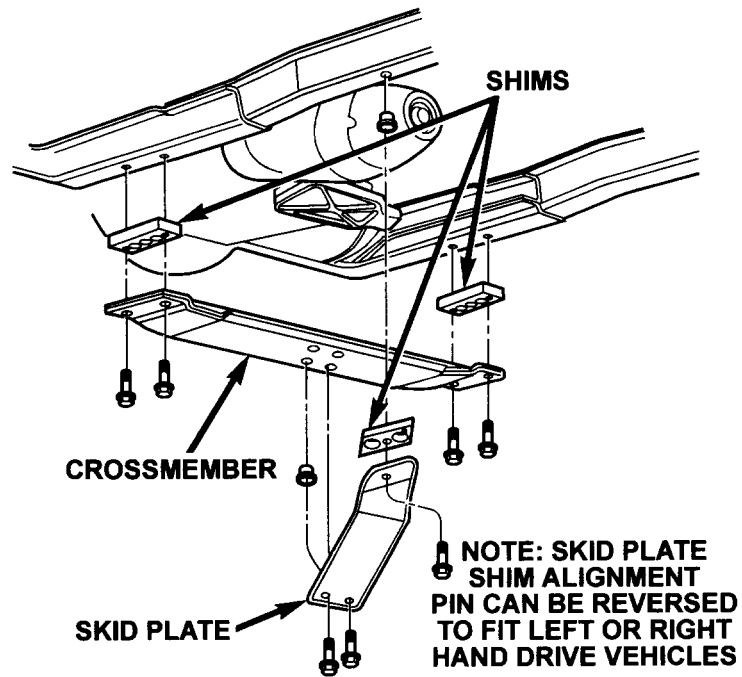
**Figure 1**

This bulletin involves installing shims to the transmission cross member to alter the drive shaft operating angles and replacing the prop shaft with a revised part containing a vibration damper.

1. Raise the vehicle and support the transmission with an adjustable jack stand to allow for removal of the transmission cross member.
2. Loosen but do not remove the engine support bracket to frame sill attaching nuts.
3. Loosen but do not remove the exhaust pipe nuts at the exhaust manifold to allow for movement during the shim installation.
4. Remove the transfer case skid plate to frame rail bolt if equipped.
5. Remove the transmission cross member to frame rail bolts.
6. Lower the cross member and install the cross member with the new shims, p/n 05011910AA, and longer bolts, p/n 06101505, and hand tighten the bolts. (See figure 1)

7. Install the skid plate shim, if equipped, and hand tighten the bolts.

8. Tighten the cross member and skid plate bolts to 41 Nm (30 ft. lbs.).
