Technical Service Bulletin

SUBJECT:
Incorrect Engine Oil
Dipstick

NO: 09-06-98
GROUP: Engine
DATE: Oct. 30, 1998

1998 (BR/BE) Ram Truck

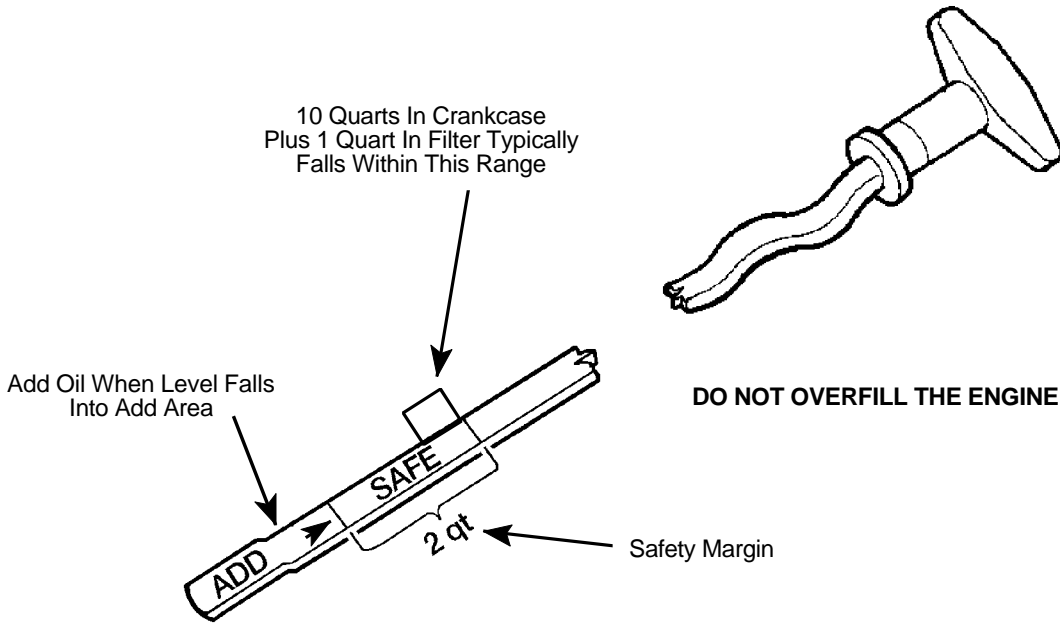
FIGURE 1

NOTE: THE TOTAL CAPACITY OF THE CRANKCASE IS 10 QUARTS PLUS 1 QUART IN THE FILTER. THE OIL LEVEL TYPICALLY READS IN THE MID TO UPPER SECTION OF THE SAFE ZONE WHEN FULL. IT DOES NOT HAVE TO BE FILLED TO THE TOP EDGE OF THE SAFE ZONE FOR THE LEVEL TO BE CORRECT (FIGURE 1).

1. Remove and discard the engine oil dipstick.
2. Install dipstick p/n 05014562AA.
3. Adjust the oil level to the proper height.
