MODELS:

1996 - 1998 (AB) Ram Van
1996 - 1998 (AN) Dakota
1996 - 1998 (BR/BE) Ram Truck
1998 (DN) Durango
1996 - 1998 (ZJ) Grand Cherokee
1996 - 1998 (ZG) Grand Cherokee (International Markets)

NOTE: THIS INFORMATION APPLIES TO VEHICLES BUILT BEFORE JAN 16, 1998 MDH (0116XX) EQUIPPED WITH GASOLINE ENGINES AND A 42/44/46 OR 47RE TRANSMISSION.

This bulletin involves installing a newly designed governor pressure sensor.

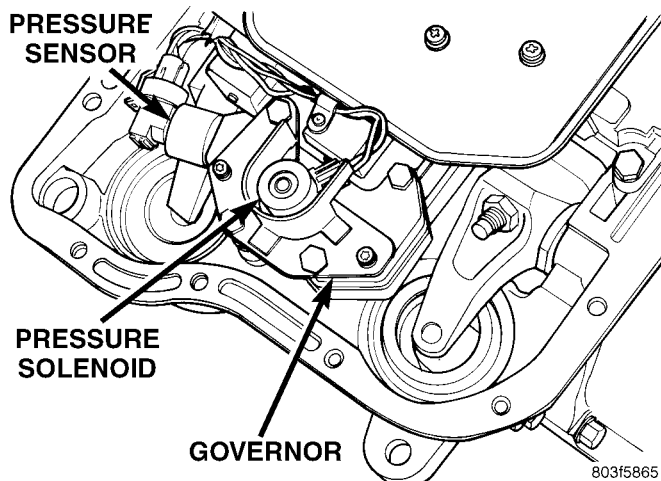
FIGURE 1

Some vehicles may experience bucking during wide open throttle (WOT) acceleration. The bucking occurs at approximately 5300 RPM. This condition may be caused by reaching the high RPM fuel shut off rev limit before the transmission can shift into the next higher gear and is most likely to occur with high electrical loads (high beams on, heated backlite, heated seats, radio, HVAC blower on MAX etc.). During high current demands, the generator may emit electrical noise that can affect the transmission governor pressure sensor output. If this occurs, the transmission may not shift properly to the next higher gear under (WOT) acceleration conditions and therefore reach the fuel shut off rev limiter. This may be seen most often between the 2-3 shift but can also be experienced between the 1-2 shift.

- 1. Following the procedures in the applicable service manual, replace the governor pressure sensor with p/n 56041403AA (Figure 1).
