Transfer Case Shifter

Noise

21-09-98

Transmission

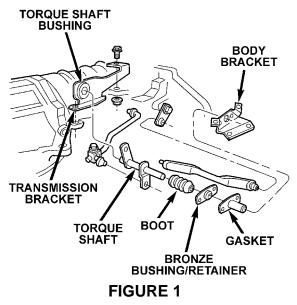
A thumping or creaking noise may be heard coming from the transmission tunnel area on acceleration or while driving over bumpy roads.

- 2. Remove the torque shaft by prying the shaft out of the green torque shaft bushing in the transmission bracket. (Refer to Figure 1) Install new bushings on the torque shaft for XJ and TJ.
- 3. Remove the bronze bushing/retainer and rubber gasket from the body bracket.
- 4. Remove the green torque shaft bushing from the transmission bracket and install the new bushing supplied in the kit.

- 4. Insert the new gasket into the body bracket.
- 5. Install the bronze bushing/retainer and tightening the screws to 5 Nm (45 in. lbs.).

- 6. Slide the boot on to the torque shaft and apply multipurpose grease (MOPAR p/n 04318063 or equivalent) to the area that the bronze bushing will contact.
- 7. Install the torque shaft and seat the boot on the bushing retainer flange.
- 8. Connect the transfer case shift linkage and adjust as necessary.
