Technical Service Bulletin

NUMBER: 09-08-99

Multi-Layer Steel (MLS) Head Gasket Installation Procedures

1995 - 1999	(FJ)	Avenger/Sebring/Talon
1995 - 2000	(JA)	Cirrus/Stratus/Breeze
1996 - 2000	(JX)	Sebring Convertible
1995 - 2000	(PL)	Neon
1997 - 2000	(GS)	Chrysler Voyager (International Market)

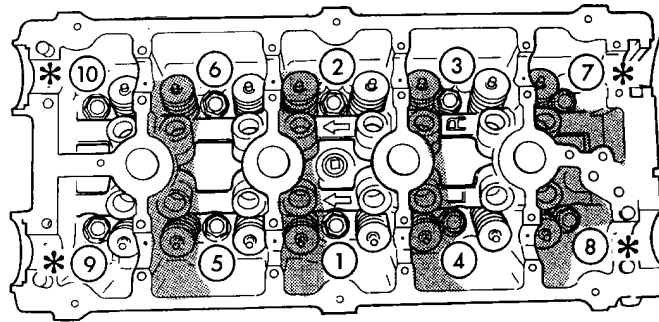
FIGURE 1

NOTE: THE 4 SHORT BOLTS ARE PLACED IN THE CORNERS.

* LOCATION OF 110 mm (4.330 in.) BOLTS 9509-243

- A. Torque all center bolts to 34 Nm (25 Ft Lbs), Torque the 4 corner bolts to 27 Nm (20 Ft Lbs) see Fig 1 for torque sequence.
- B. Torque all center bolts to 68 Nm (50 Ft Lbs), Torque the 4 corner bolts to 47 Nm (35 Ft Lbs) see Fig 1 for torque sequence.
- C. Re-torque all center bolts to 68 Nm (50 Ft Lbs), Re-torque the 4 corner bolts to 47 Nm (35 Ft Lbs) see Fig 1 for torque sequence.
- D. Tighten all bolts in the specified sequence (Fig 1) an additional 90° (1/4 turn).
