# Technical Service Bulletin

NUMBER: 09-06-00

Changes To Timing Belt Tensioner Components

1999 - 2000 (GS) Chrysler Voyager (International Market)  
1999 - 2000 (JA) Cirrus/Stratus/Breeze  
1999 - 2000 (JX) Sebring Convertible  
1999 - 2000 (PL) Neon

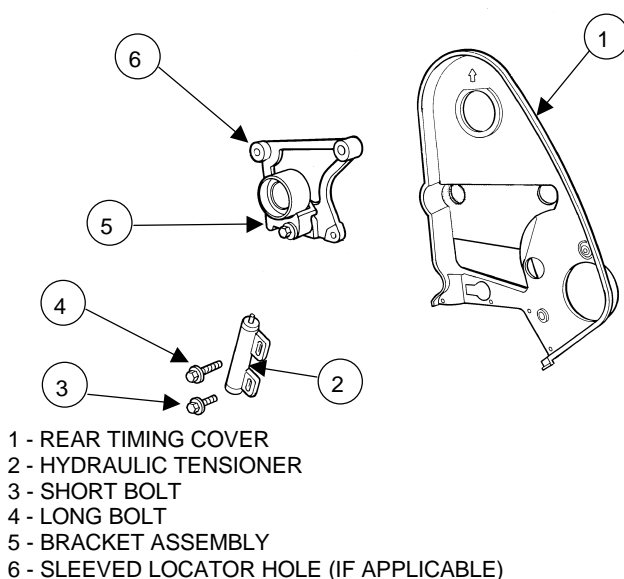
**FIGURE 1**

1 5018399AA Kit, Timing Tensioner Component (1999 Models) w/o dowel locator  
1 5018400AA Kit, Timing Tensioner Component (2000 Models) w dowel locator  
Each kit consists of a tensioner w/attaching bolts, tensioner pivot assembly, and rear timing belt cover (Figure 1).

3. Install a new rear cover and bracket assembly, from kit p/n 5018399AA 1999 Models w/o dowel locator or p/n 5018400AA 2000 Models w dowel locator (Figure 1). Torque all applicable bolts to the specifications listed in the service manual.

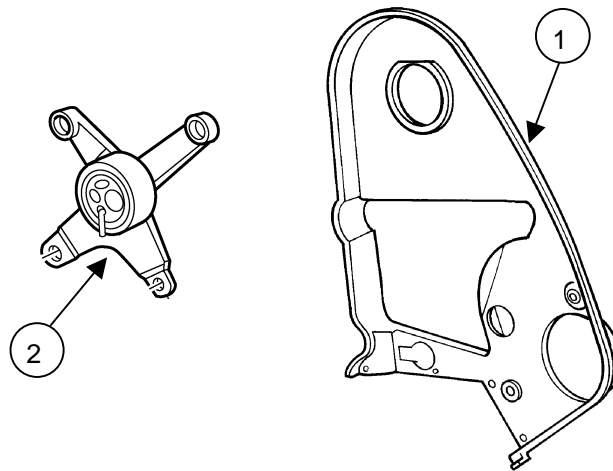
**FIGURE 2**

1 - REAR TIMING COVER  
2 - MECHANICAL TENSIONER

2. Remove and discard the mechanical timing belt tensioner assembly and rear-timing belt cover (Figure 2). Save the bolts that were used to mount the mechanical tensioner to the engine.

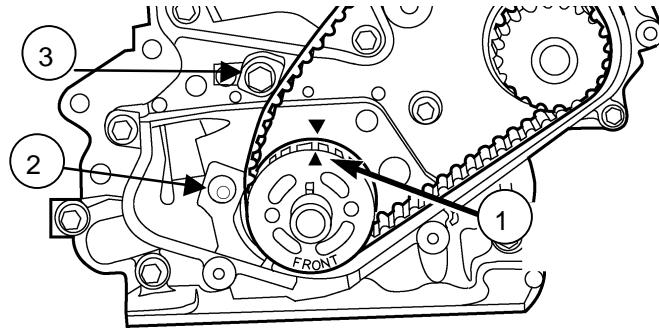
**FIGURE 3**

- 1 - CRANKSHAFT SPROCKET  
 2 - OPEN HOLE (POSITION FOR TENSIONER)  
 3 - UPPER BOLT - DISCARD (POSITION FOR TENSIONER)

4. Follow the timing procedures (if required) in the service manual up to the point of rotating the crankshaft sprocket to TDC to take up slack in the belt.
5. To install the hydraulic tensioner, first remove and discard the upper bolt as shown in Figure 3. Install the hydraulic tensioner with the 2 bolts from the kit into the location shown in Figure 3. Do not tighten the 2 bolts at this time.

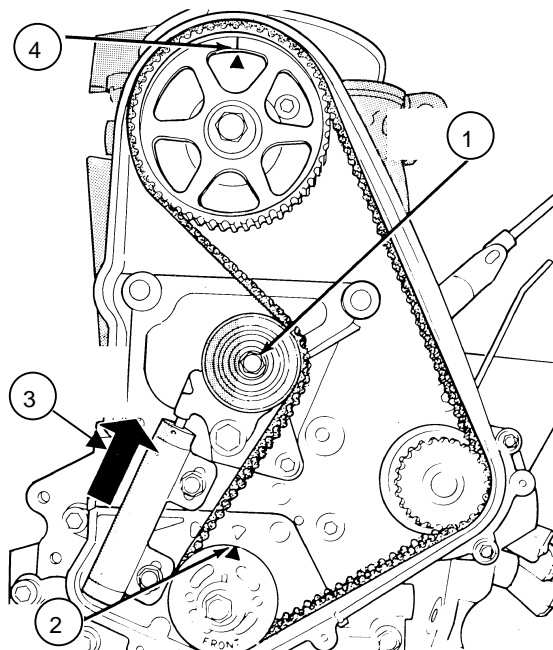
**FIGURE 4**

- 1 - INSTALL TORQUE WRENCH HERE  
 2 - CRANKSHAFT T.D.C.  
 3 - MOVE TENSIONER UP TO REMOVE CLEARANCE  
 4 - CAMSHAFT T.D.C.

6. Using a torque wrench on the bracket assembly pulley (Figure 4), apply 28 Nm (250 in lbs) of torque against the timing belt.

7. While torque is being applied to the pulley/belt, move the tensioner up against the bracket assembly and tighten the 2 bolts to 31 Nm (275 in lbs).
8. Pull the tensioner plunger pin. Pretension is correct when the pin can be removed and installed while in location.
9. Rotate the crankshaft 2 revolutions and check the alignment of the timing marks. If alignment is OK, complete the re-assembly of the engine.
