Technical Service Bulletin

NUMBER: 08-001-02

Rear Window Defogger Inoperative

2001 - 2002 (JR) Sebring Convertible

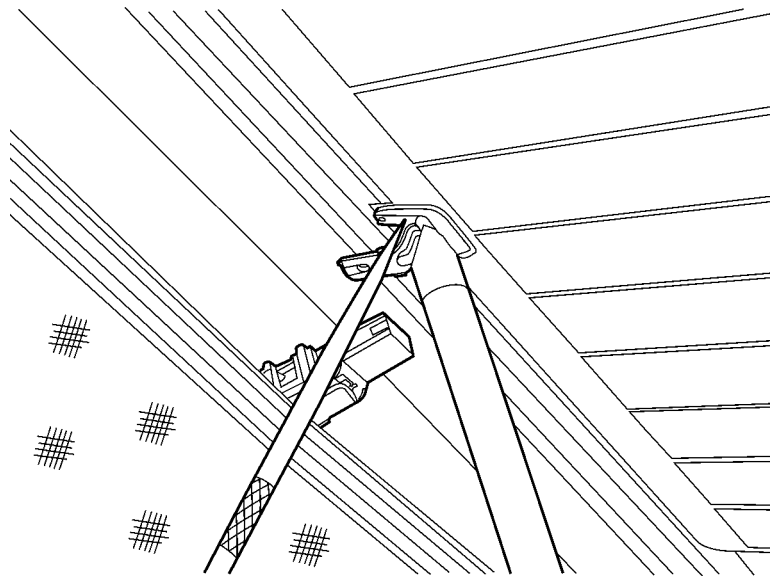
Fig. 3 CLIP ORIENTATION AND ATTACHMENT

This bulletin involves replacing and reorienting BOTH rear window defogger grid terminal clips so the tips face outboard, as necessary. Failure to reorient the terminal clips may result in an additional failure.

6. Holding the new terminal clip with a metal “pick” or other suitable pointed tool, place the new terminal clip in the same location as the original terminal clip but with the tip of clip facing outboard.

NOTE: THE TIP OF THE TERMINAL CLIP MUST FACE OUTBOARD. CLIPS ARE PRE-SOLDERED AND FLUXED. DO NOT REUSE A CLIP IF IT HAS BEEN HEATED PREVIOUSLY.

7. Place the solder gun on the new terminal clip and heat until the solder flows. Remove the solder gun and continue to hold the clip in position for 5 seconds. Let the solder area cool for 10 minutes, (Fig. 3).
