NUMBER: 13-001-02

GROUP: Frame & Bumper

Squeak-Like Sound From Front Bumper Crossmember

2002 (KJ) Liberty / Cherokee

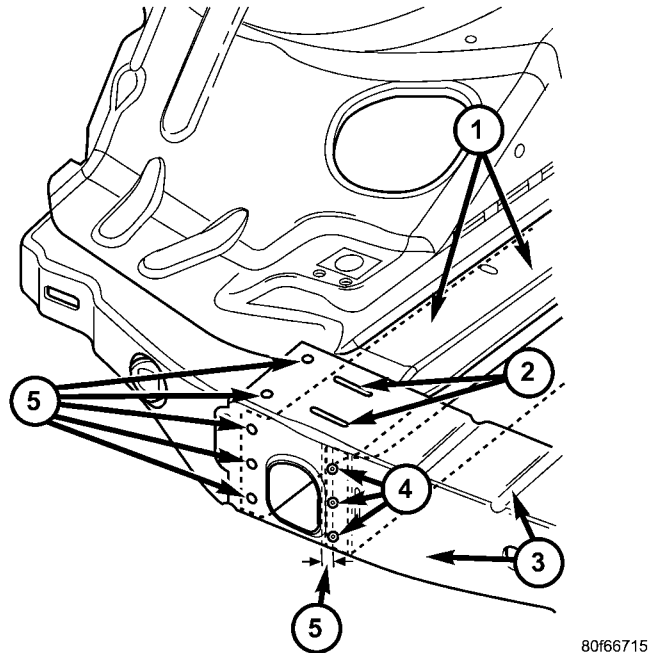
Fig. 1 FRONT BUMPER CROSSMEMBER

A customer may experience a squeak-like sound when driving slowly over driveway entrances, road bumps, or when performing parking lot maneuvers. The squeak-like sound may occur when the vehicle body/frame is flexed (twists). This condition may occur when the front edge flange of either frame rail rubs against the backside of the front bumper crossmember.

1. Remove the vehicle front grill and fascia. For additional disassembly and assembly instructions refer to the Frame & Bumper Section of the appropriate 2002 Service Manual.
2. Remove the screw used to secure the right side frame rail end cap to the front bumper crossmember. The frame rail cap covers the rectangular access hole in the crossmember. Remove the end cap.
3. Draw a vertical line from top to bottom across the width of the front crossmember. The vertical line should be positioned so that it is 9 mm to the right, and parallel to, the inboard vertical edge of the right access hole (in the crossmember). See illustration (Fig. 1).

- 1 - Right Side Frame Rail
- 2 - Weld Lines - Already Present
- 3 - Front Bumper Crossmember
- 4 - Mark Line As Specified, Clamp Panels, Center Punch, Drill 3/16 in. Holes, Add Rivets
- 5 - Draw Vertical Line 9 mm From Inboard Edge Of Rectangular Access Hole
- 5 - Five (5) Spot Welds - Already Present

4. Mark the vertical line in three places as illustrated. Each top and bottom mark is to be 20 mm (.750 in.) from the top and bottom edge of the crossmember respectively. The middle mark is to be centered at 50 mm (2.0 in.) from the top and bottom edge of the crossmember.
5. Center punch all three marks to prevent drill bit drift and improperly positioned holes.
6. Position locking pliers through the rectangular hole in the crossmember. Tightly clamp the crossmember panel to the frame rail edge flange. Position the locking pliers so that it will not interfere with the drilling of the three holes or with the heads of the rivets when they are installed.
7. Using a 3/16 size drill bit, drill a hole at each of the three marks made on the vertical line. Drill all the way through both metal panels (the crossmember and frame rail edge flange).

8. Make sure the area around the three drilled holes are free of metal burrs. Install a suitable corrosion resistant material (e.g. paint primer) to the drilled holes.
9. With the two panels securely held together by the locking pliers, install a rivet (p/n 34201208) in each drilled hole.
10. Remove the locking pliers.
11. Move to the rectangular access hole located at the left side (driver side) of the front bumper crossmember.
12. Perform steps 2 through 10 in a similar manner so that the installed rivets are positioned along the inboard edge of the driver side rectangular access hole. The left side repair should mirror the repairs made to the right side.
13. Verify that the squeak-like sound condition has been corrected.
14. Install both end caps and screws.
15. Install the front fascia and grill.
